# Manhole Inspection Summary

Manhole # S25EE1040MH

**Inspection** ☐ Is Incomplete Rating: **4) Poor**

**Location** Address: **1015 RECTORY LN**

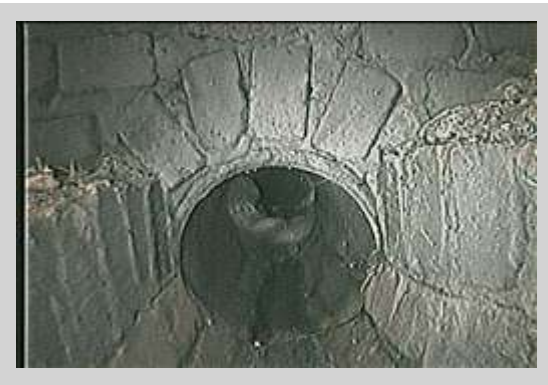
### 8 in. Circular Gravity Sewer Pipe Out @ 12 O'Clock

Rod and Bar (Angled)

Deposits: ☐ None ☐ Mud ☐ Sludge ☒ Debris ☒ Grease

Silt Depth: **1** (in.) Deposits Extent: **Light**

Infiltration: **Evidence** Pipe Seal Cond: **Unknown**
